MERMAID BLACKSMITH SHOP AND STABLE (7NC-D-106B)

RESULTS OF FIELD INVESTIGATIONS

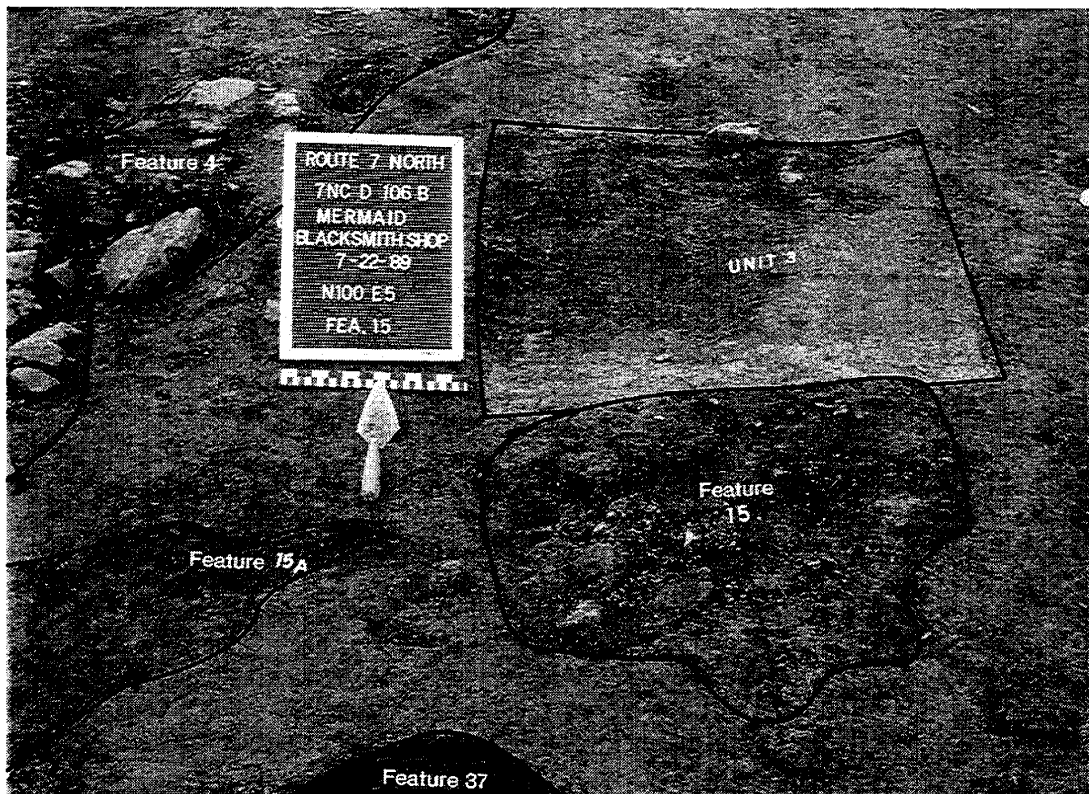
PLATE 21

Feature 15, Prior to Excavation

Feature 15 was located in Test Unit N95E5 and was a roughly circular dark brown silty loam stain measuring about 2.4' in diameter (Figure 24). The northern edge of the feature had been barely clipped by the excavation of Test Unit 3 during the Phase I testing of the site (Catts et al. 1986:158, Plate 21). Feature 15 was 1.7' deep and was packed with large stones and cobbles, mortar, over 300 grams of brick and 575 grams of iron slag, redware and pearlware fragments, cut and wrought nails, iron sheeting, bar stock, and metal debris (Plate 22).

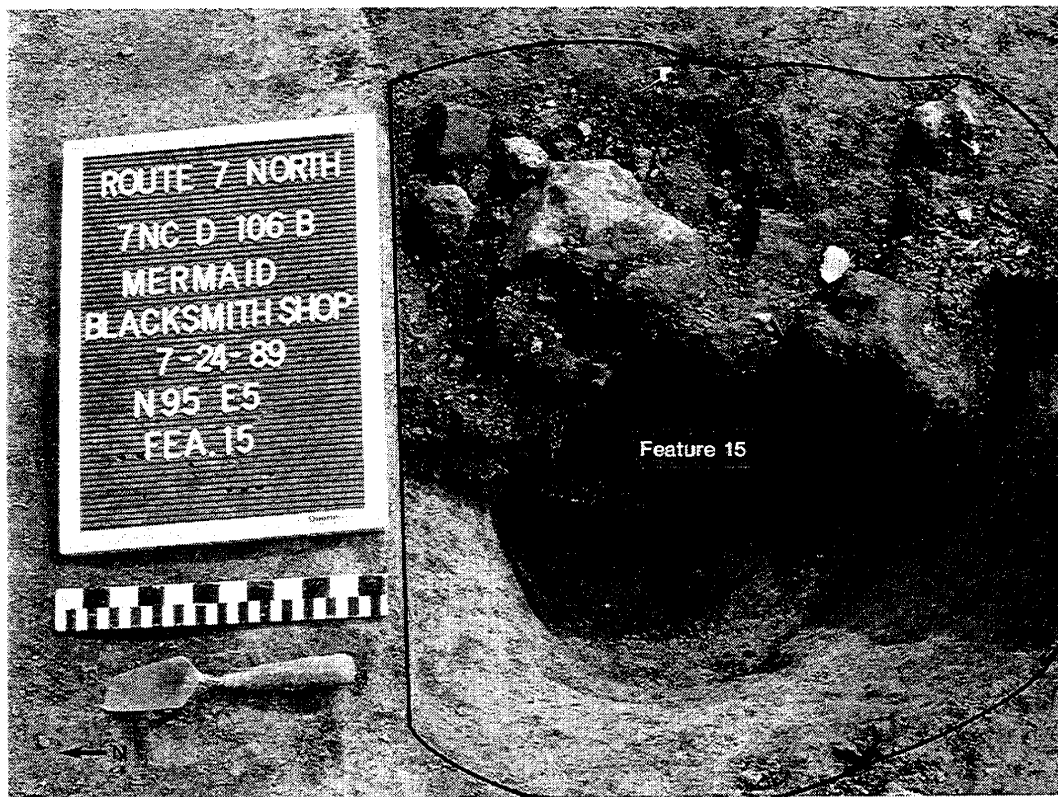
PLATE 22

Feature 15, Cross-Section

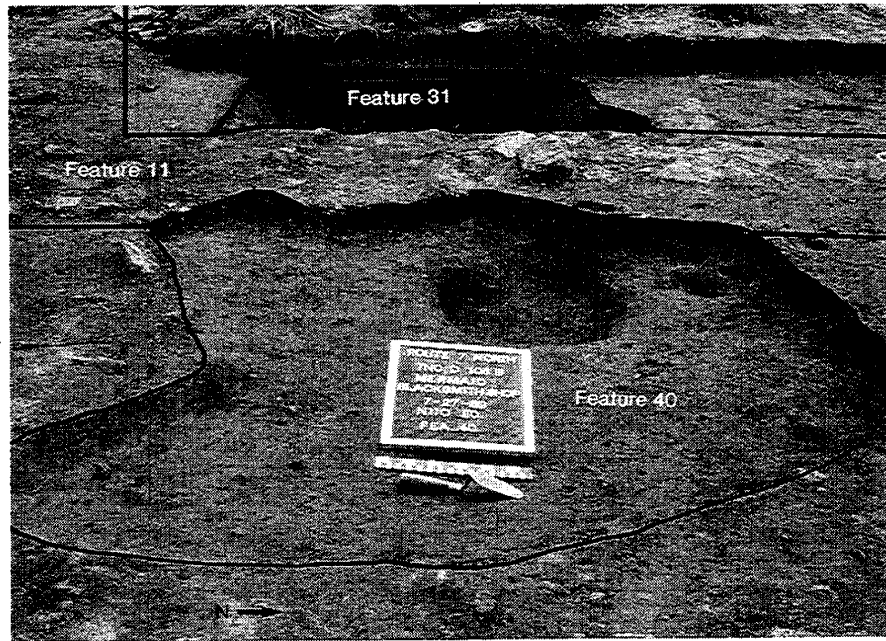
PLATE 23

Feature 40 (Trash Pile), Behind the Fuel Shed, After Excavation

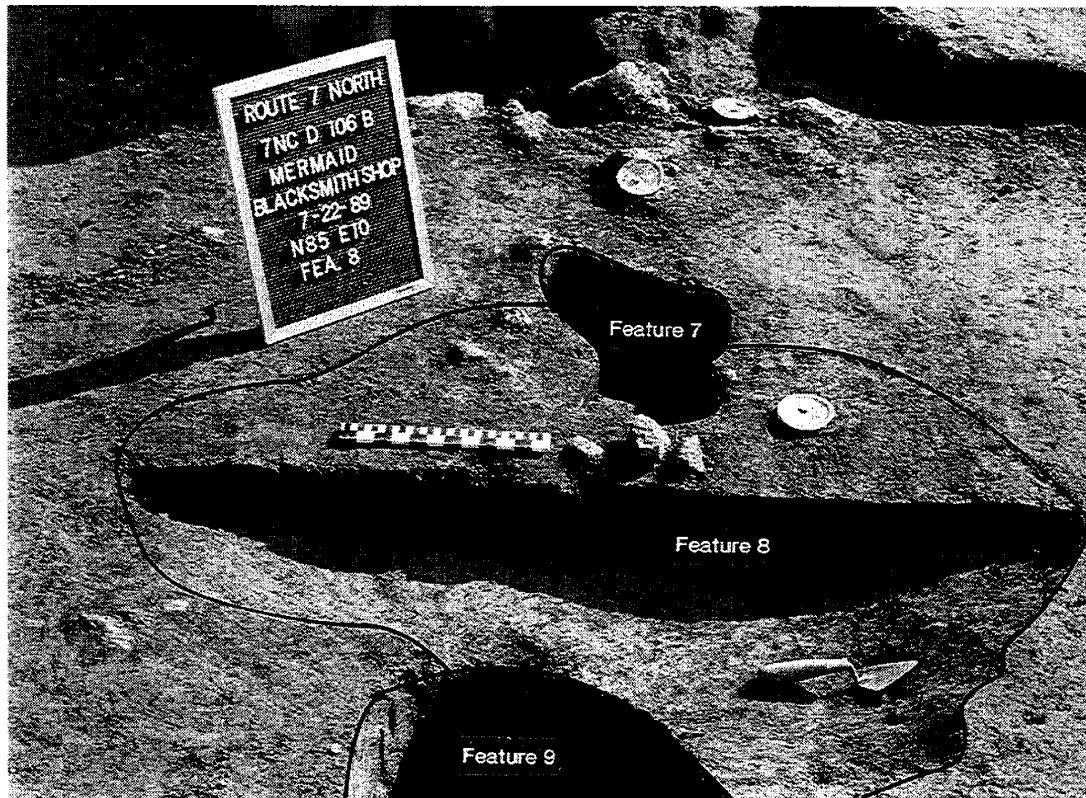
PLATE 24

Features 7, 8, and 9, Cross-Sections

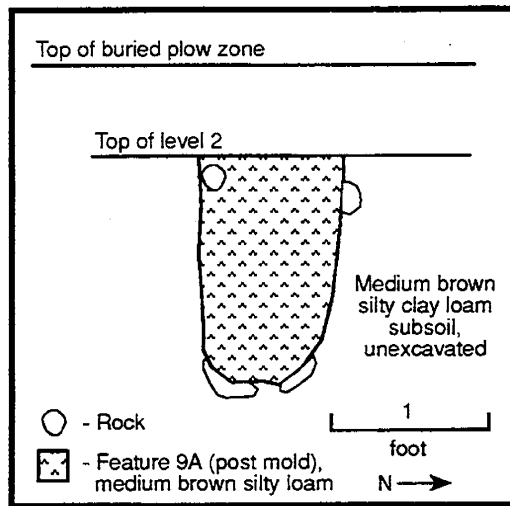
FIGURE 25
Profile of Feature 9

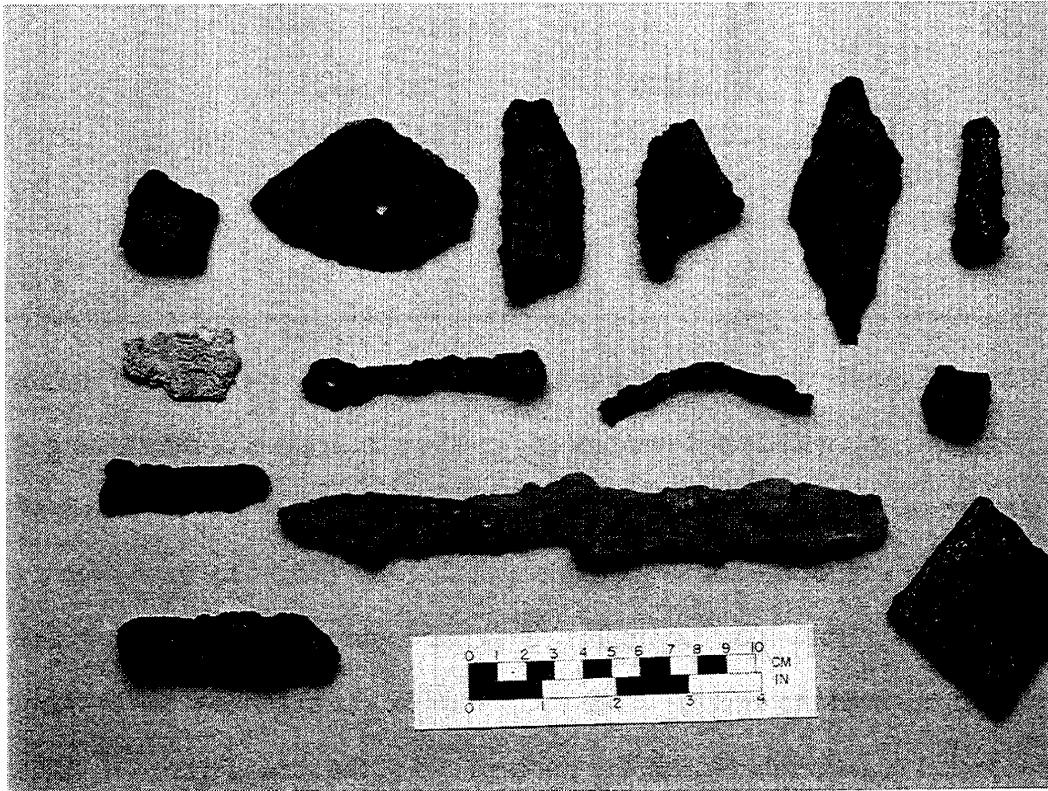
PLATE 25

Iron Scrap from Mermaid Blacksmith Shop and Stable Site

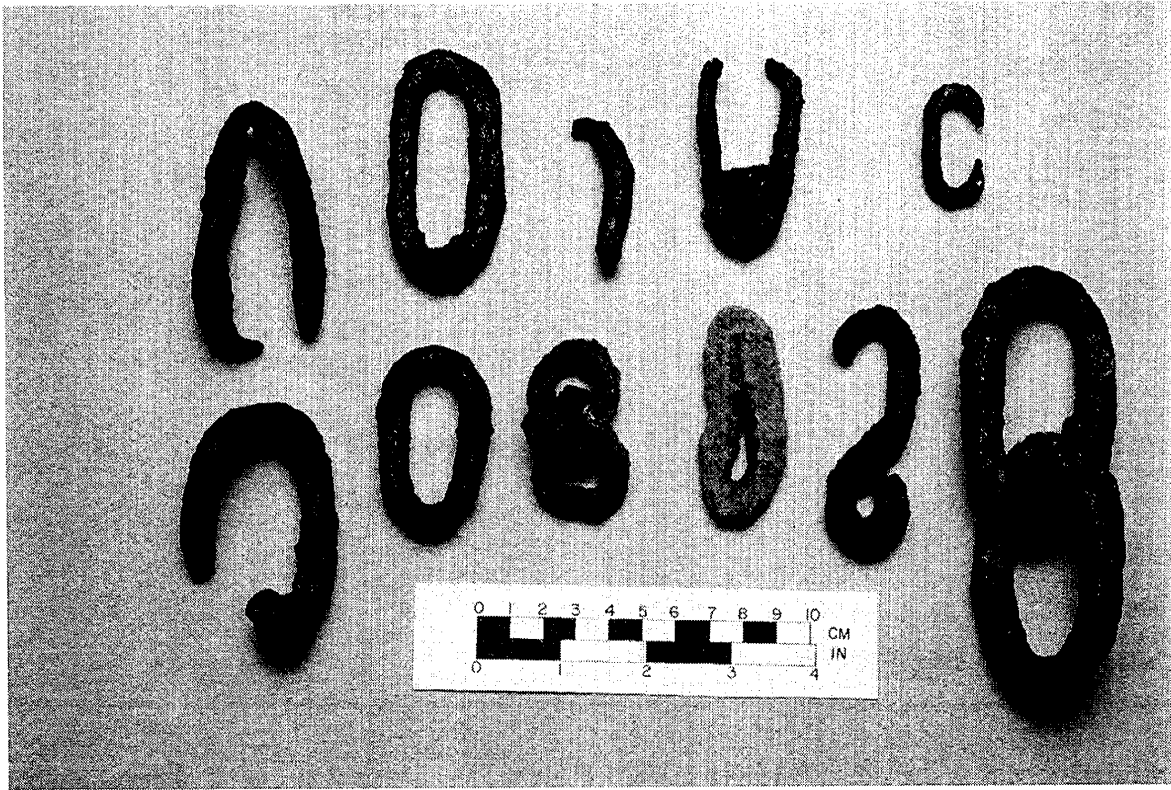
PLATE 26

Chain Links from Mermaid Blacksmith Shop and Stable Site

Ninety-two fragments of worn out chain links of various sizes (Plate 26) were the next most common artifacts found. As with the scrap iron and nails, this artifact type was found primarily in the six contiguous excavation units noted previously. Four times as many rivets as bolts and screws were found at the site.

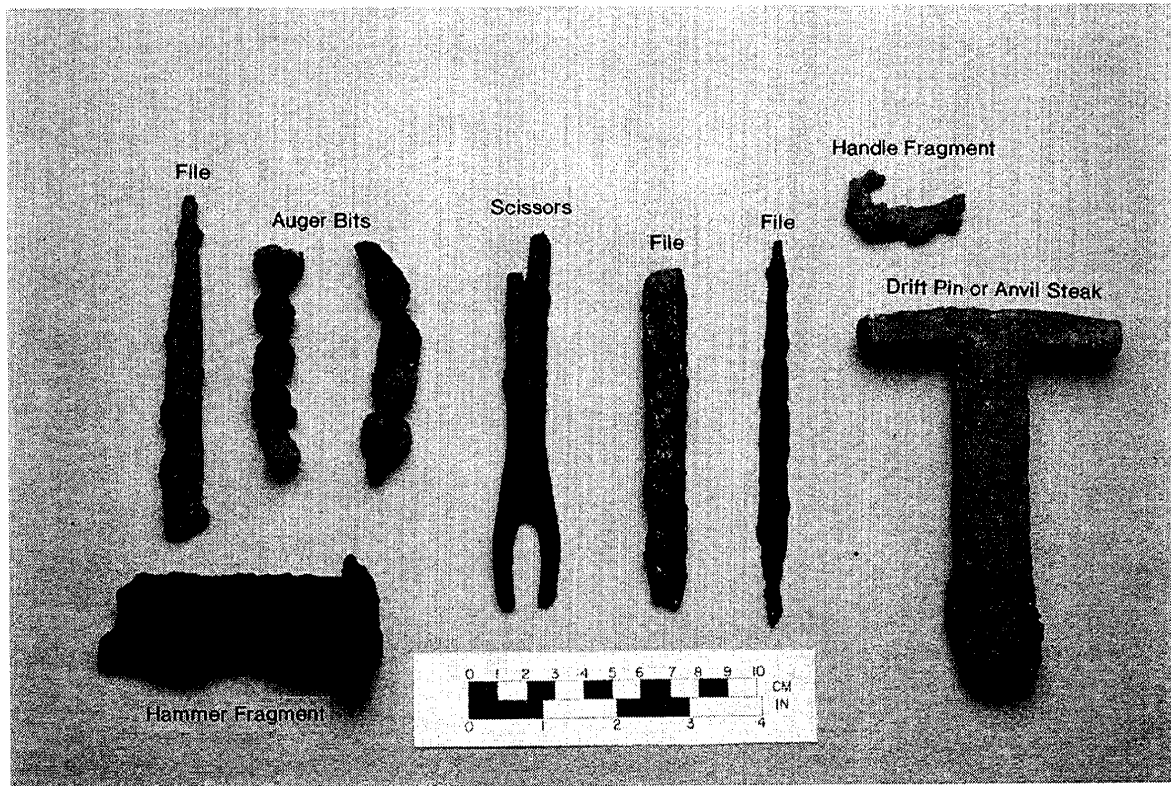
PLATE 27

Tools Recovered from Mermaid Blacksmith Shop and Stable Site

Tool parts recovered suggest the range of manufacturing and repair that the Mermaid smiths were engaged in, and represent farming, wood working, blacksmithing and domestic uses (Table 14; Plate 27). Twenty-four hand tool fragments were found, including auger bit fragments, draw knives, nine files, a hammer, a mortising chisel, a fragment of a plane blade, a stake anvil, fragments of scythes and sickles, an axe head, a pair of scissors, and three punches. Agricultural equipment parts that were recovered included a cultivator blade and two plow tips. A variety of other objects were also recovered

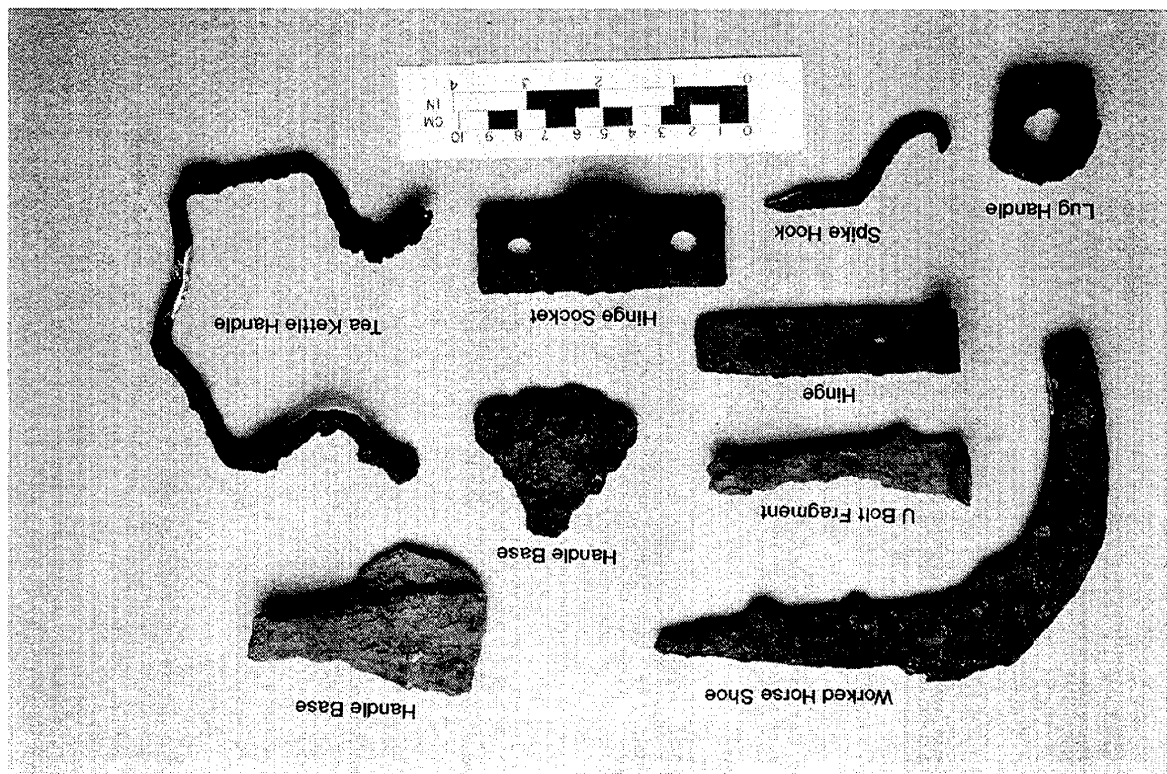
PLATE 28

Assorted Metal Objects from Mermaid Blacksmith Shop and Stable Site

such as handles, pieces of horse tack (including horse shoes, bits, swivel hooks, hame clips, and a saddle tree bracket), wagon parts (portions of single and double trees, end clips, straps, and shoe bolts), and keys (Plates 28 and 29). Numerous unidentified rusted iron lumps were also recovered. In almost every instance the highest proportion of the artifacts occur in the same six contiguous excavation units that comprised the location of the shoeing shed. The majority of the metal artifacts were broken or worn out and usually in small pieces.

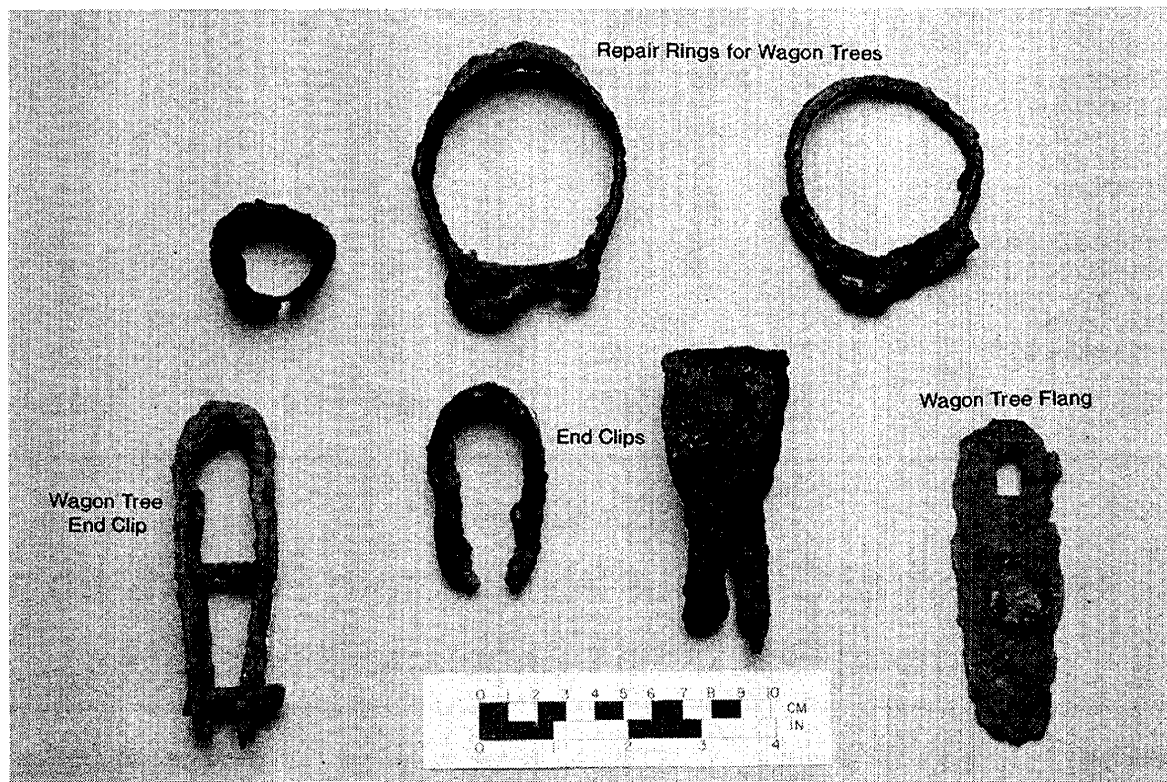
PLATE 29

More Assorted Metal Objects from Mermaid Blacksmith Shop and Stable Site

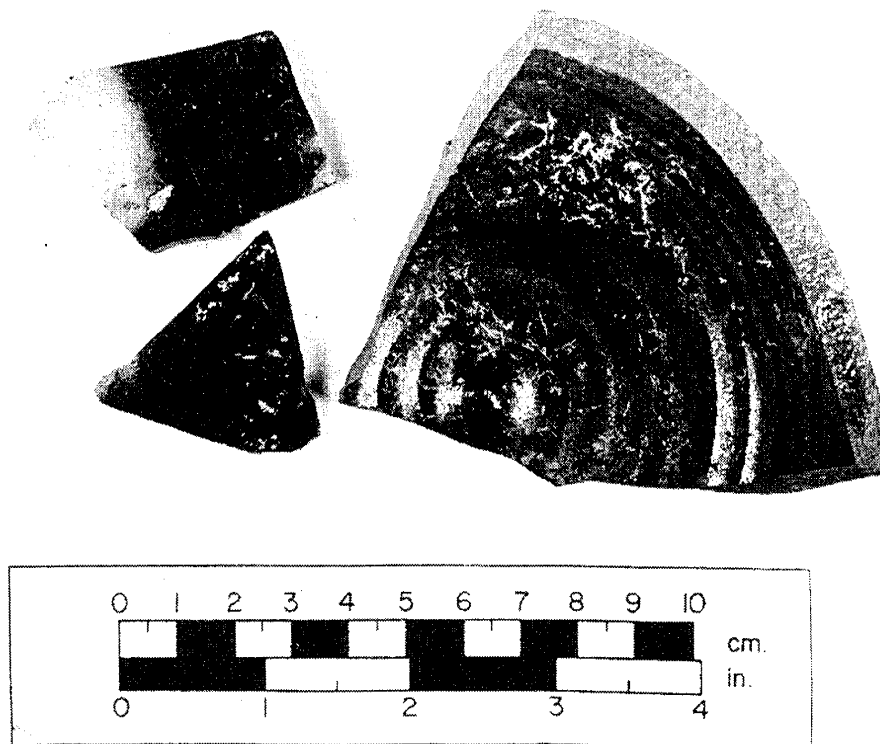
PLATE 30

Redware Jug or Pitcher, Mermaid Blacksmith Shop and Stable Site

Of all the features at the site, Feature 11 yielded the broadest range of ceramic types and vessels, and the majority of these vessels were hollow forms. Redware vessels recovered included fragments of a very distinctive dark brown bifacially glazed jug or pitcher from the southeastern end of the blacksmith shop; portions of this vessel were also found in Feature 27 (Plate 30). Sherds, including rim fragments, from at least two separate redware tankards, both with dark brown bifacial glazes, were

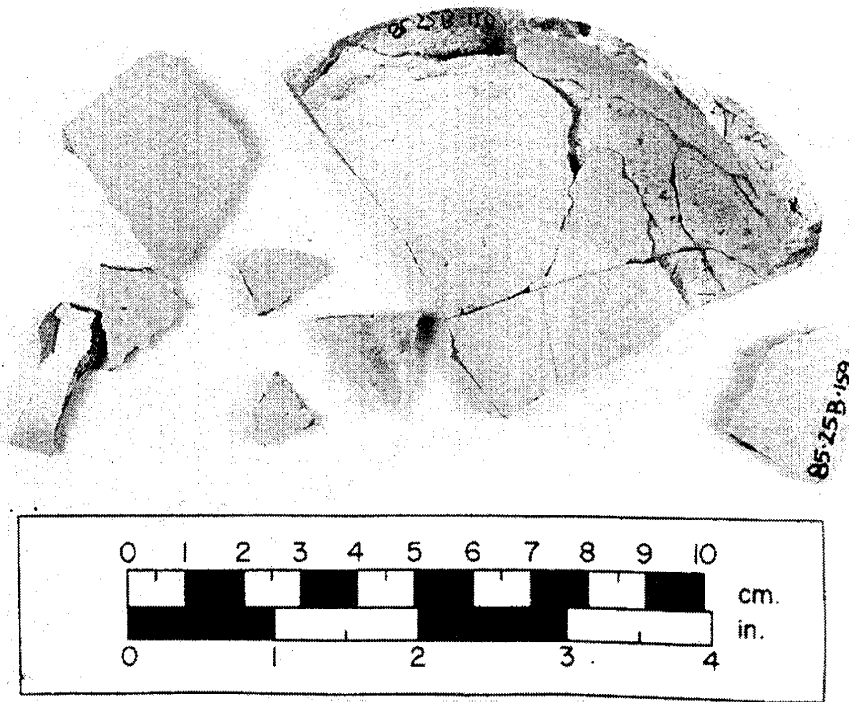
PLATE 31

Yellowware Vessel, Mermaid Blacksmith Shop and Stable Site

The sherds of one hollow form yellowware vessel, probably a 4 1/2" diameter pitcher, were found primarily in Test Unit N100W5, but were also found spread throughout Test Units N105W5, N105W10, and N120W5 (Plate 31). Fragments of a badly exfoliated whiteware baker, 2" deep and probably oblong in shape, with willow pattern decoration, were recovered from N110W5 (Plate 32). The presence of these vessels only in the northern end of the Feature 11 are useful in providing a rough chronology for the addition, suggesting a date after circa 1830 for the construction of the fuel shed.

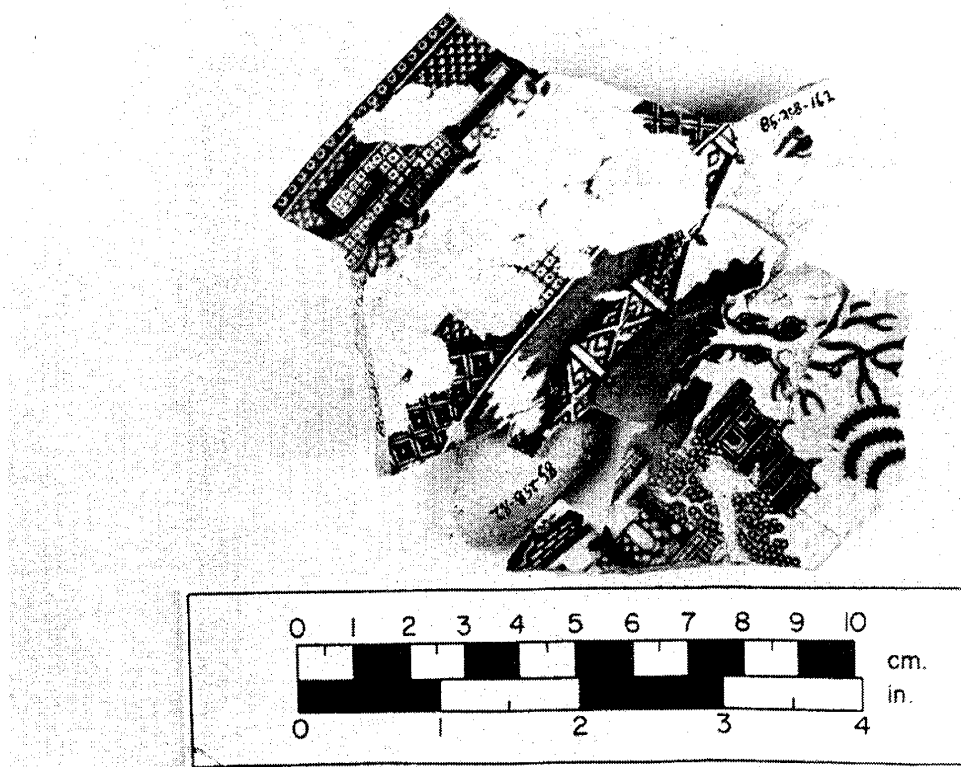
PLATE 32

Whiteware Baker, Mermaid Blacksmith Shop and Stable Site

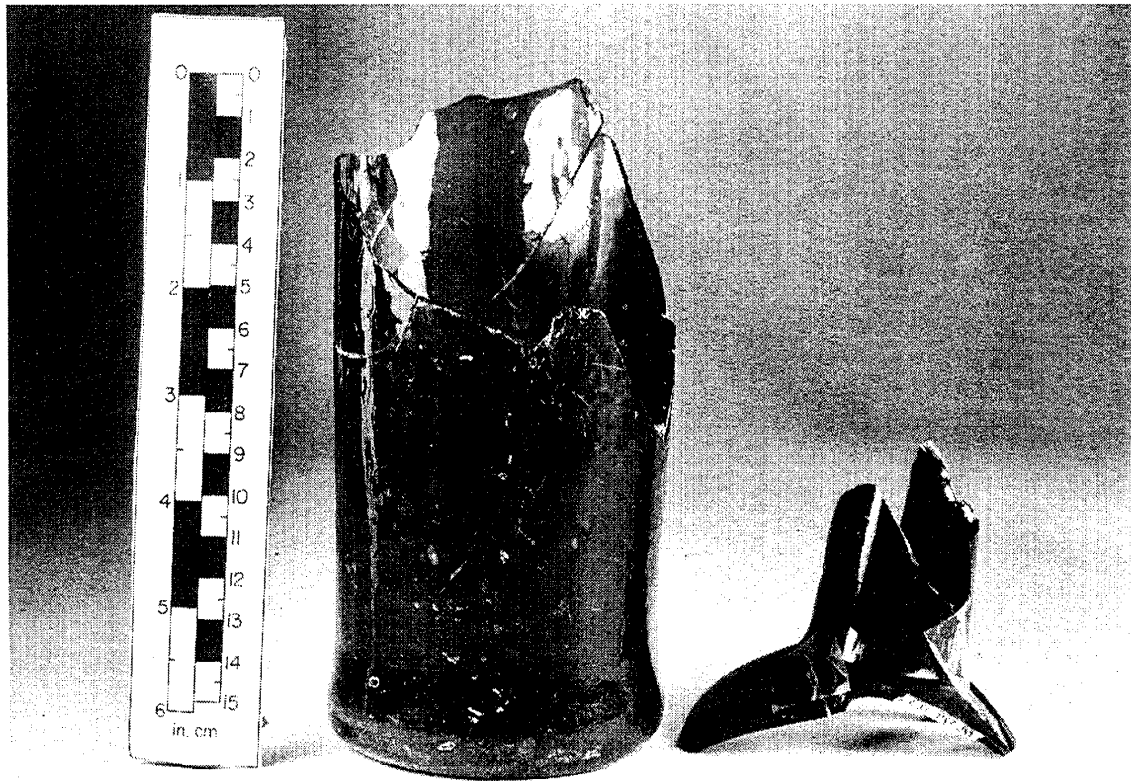
PLATE 33

Bottles from Mermaid Blacksmith Shop and Stable Site

A minimum of five glass bottles were recovered from the blacksmith shop excavations, all from feature contexts. Three of these were black glass, dip-molded wine bottles dating between 1780 and 1825 (mean date circa 1804) (Plate 33). Parts of two of these bottles were found in Features 4 and 31; the third wine bottle was recovered exclusively from Feature 40. The fourth bottle from the site was a square gin liquor bottle of black-green color and dip-molded. Found in Feature 40, it dates between 1740 and 1840 (mean date 1790). Thus Features 4, 31 and 40 represent a late eighteenth to early nineteenth-century trash disposal at the site. The fifth bottle was recovered from Features 11 and 20, and was an amber oval strap flask made in a three-piece mold (post dating 1850). Probable date range is 1850-1917 (mean date 1883.5). This bottle could be related to the demolition of the shop and sheds.

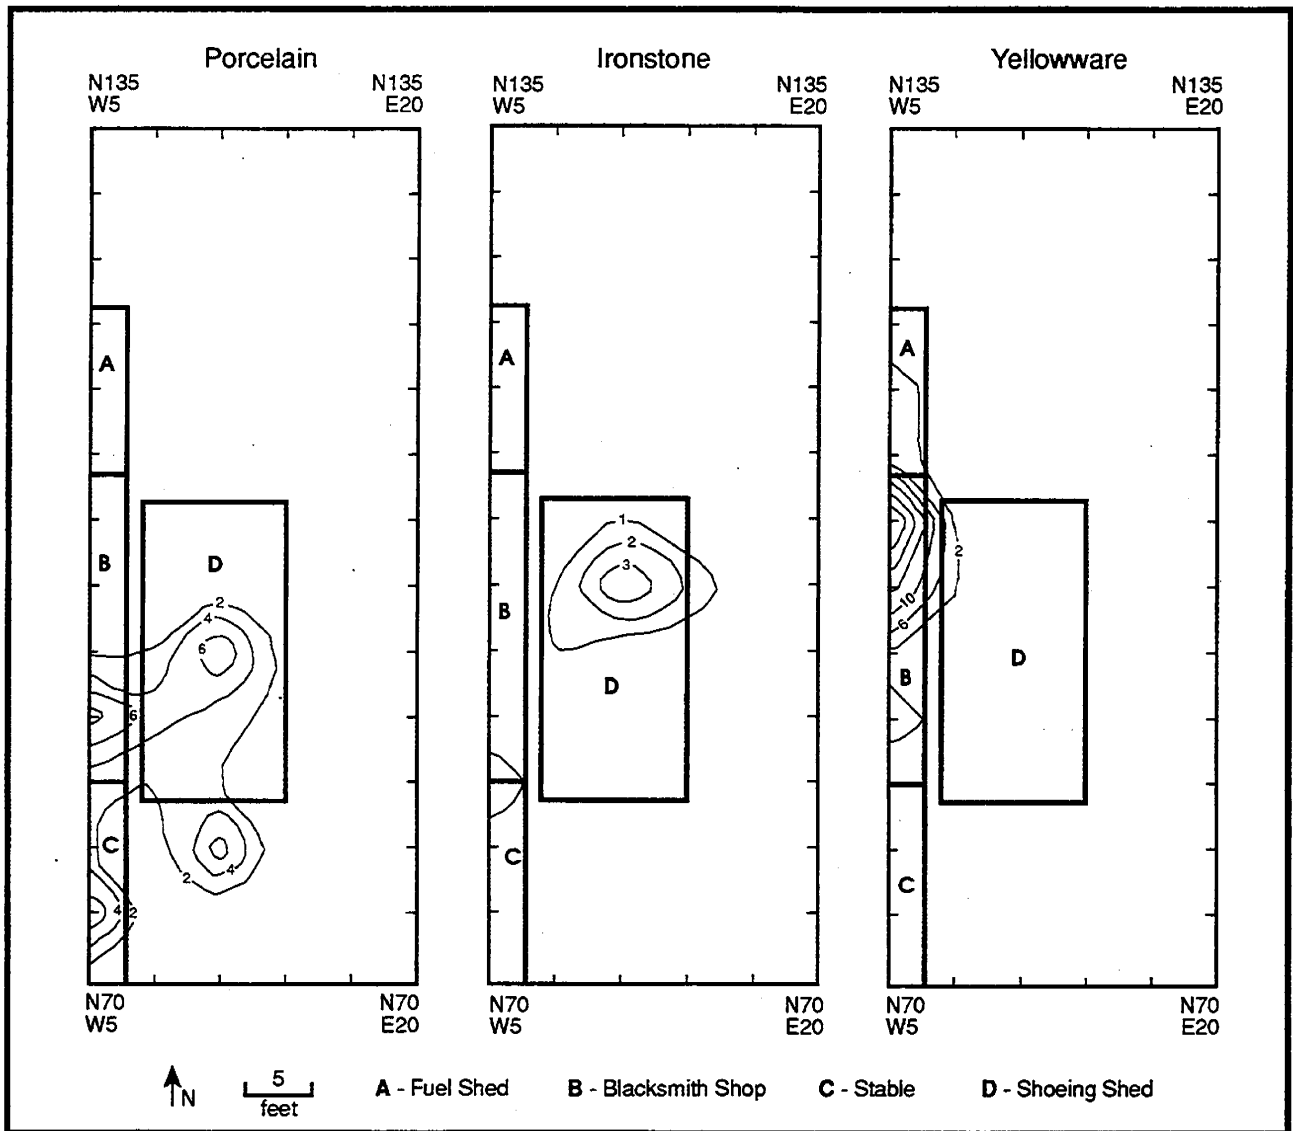
FIGURE 27

Distribution of Porcelain, Ironstone, and Yellowware Sherds in the Plow Zone

Whiteware sherds were more common in the plow zone units than in the features. Like the pearlware fragments, the whitewares were mostly concentrated inside of the shoeing shed, and seemed to concentrate in the vicinity of Feature 2. Pearlware and whiteware fragments seemed to extend beyond the southern wall of the shoeing shed, suggesting that there may have been a door or entrance into the shed from this direction (Figure 26). Both hard and soft paste fragments of porcelain were lightly spread throughout the interior of the shed, and like the pearlware and whiteware, there was a small concentration of porcelain outside the southern end of the shed (Figure 27). Ironstone fragments were sparse in the plow zone and were also concentrated inside the shed (Figure 27).

The distribution of yellowware sherds was different from the other ceramic types. The yellowware fragments were concentrated along the rear wall of the shop and fuel shed addition (Figure 27). This distribution may be indicative of a date of construction for the fuel shed between 1830, the beginning date for yellowware production, and 1912, the date that the shop and sheds were razed.

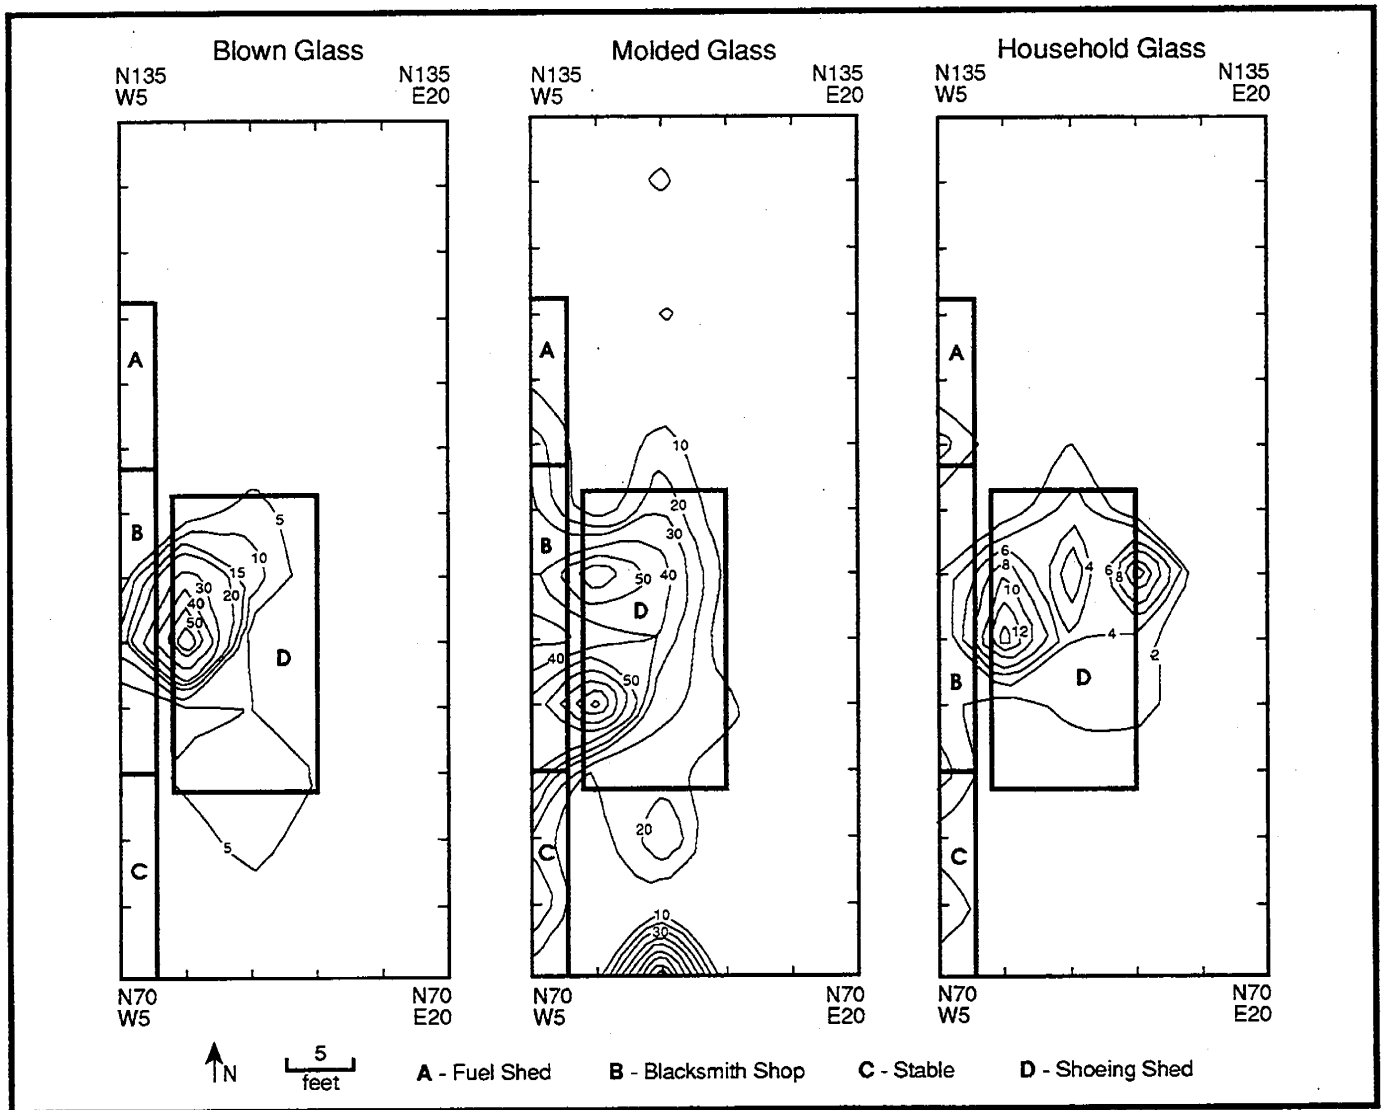
FIGURE 28

Distribution of Blown Glass, Molded Glass, and Household Glass Sherds in the Plow Zone

Bottle glass fragments recovered from the plow zone displayed similar distribution patterns to those seen with the ceramics. Sherds of bottle glass, household, and table glass were found in four primary locations: associated with Feature 4, spread throughout the inside of the shed, around the immediate limits of the shed, and in a trash disposal area mentioned earlier behind the stable (Figure 28). Tobacco pipe fragments were very sparse in both feature and plow zone contexts, and their distribution did not conform to that of any other artifact concentrations. The few pipe and bowl fragments that were found were located to the south of the shoeing shed, between the suspected

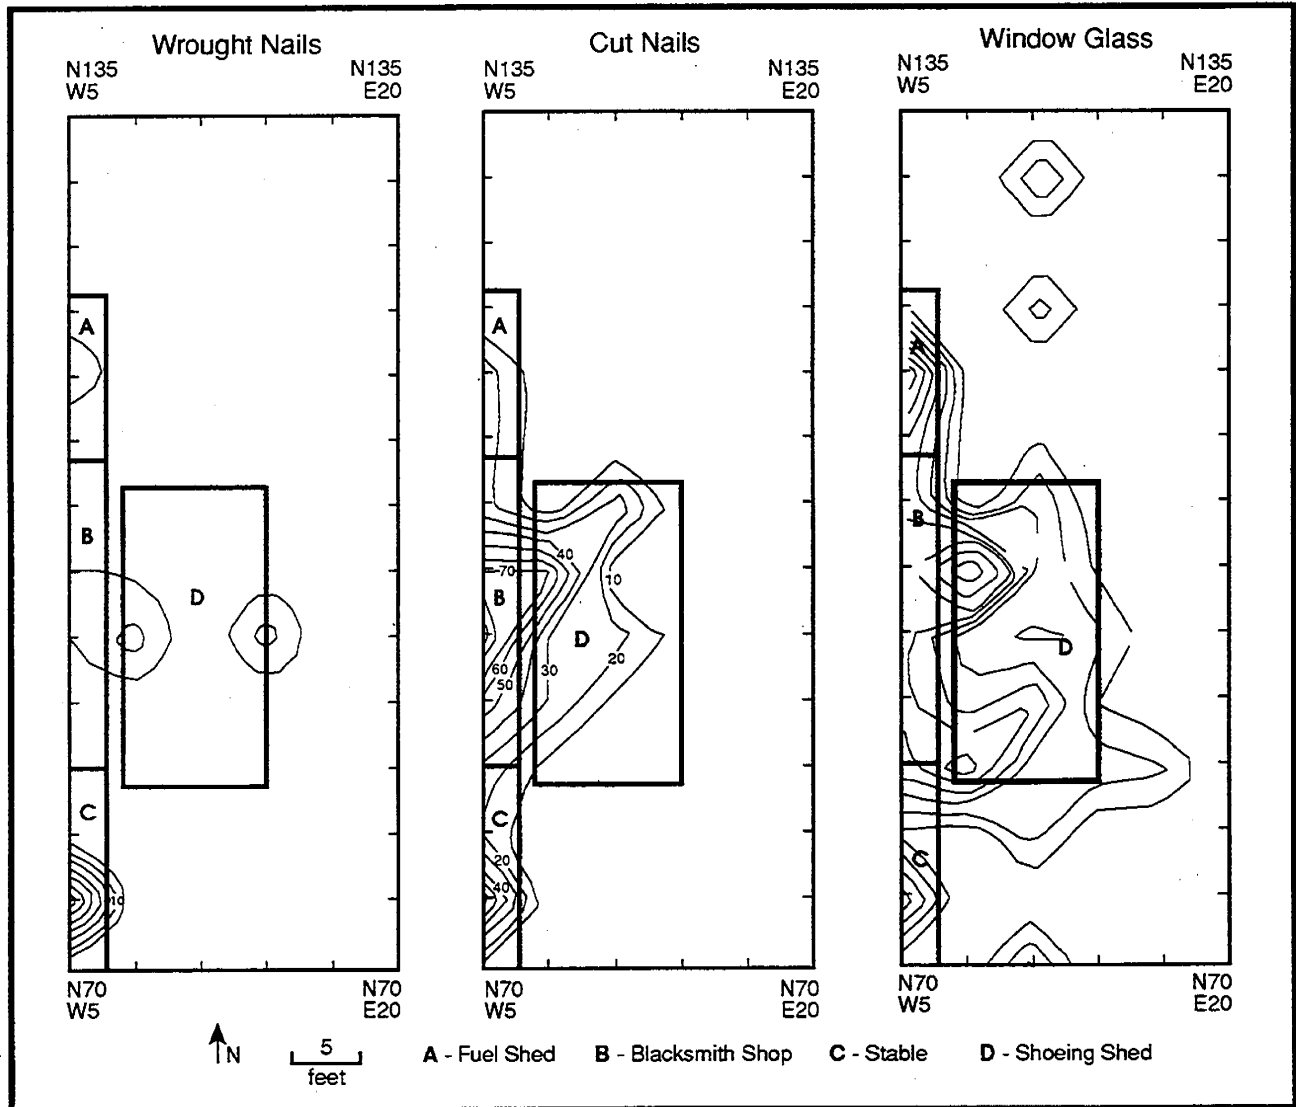
FIGURE 29

Distribution of Wrought Nails, Cut Nails, and Window Glass in the Plow Zone

when cut nails became the norm (Mercer 1976) (Figure 29). There was also a general absence of wire nails at the site, indicating that the structures were already in place by the time wire nails became common. Also, that there were probably few repair jobs at the site (no doubt due to the stone construction of the stable, shop, and sheds). A small concentration of wrought, cut, and wire nails at N75W5, along with brick fragments, may indicate a disposal area, or perhaps one of these repair locations.

The distribution of window glass at the site may be indicative of either window locations or trash disposal areas, or, a combination of both (Figure 29). There was a dense concentration of window glass in the plow zone units above Feature 4 - perhaps the location of a rear shop window or archaeological evidence for the filling of the shoeing pit. A similar, though smaller peak of window glass was found in the vicinity of Feature 22, inside the shoeing shed, again suggesting either a window location in the shop wall or trash disposal. Window glass distributions also suggest that a window may have been located in the southeastern corner of the shoeing shed, in the rear wall of the coal shed, and

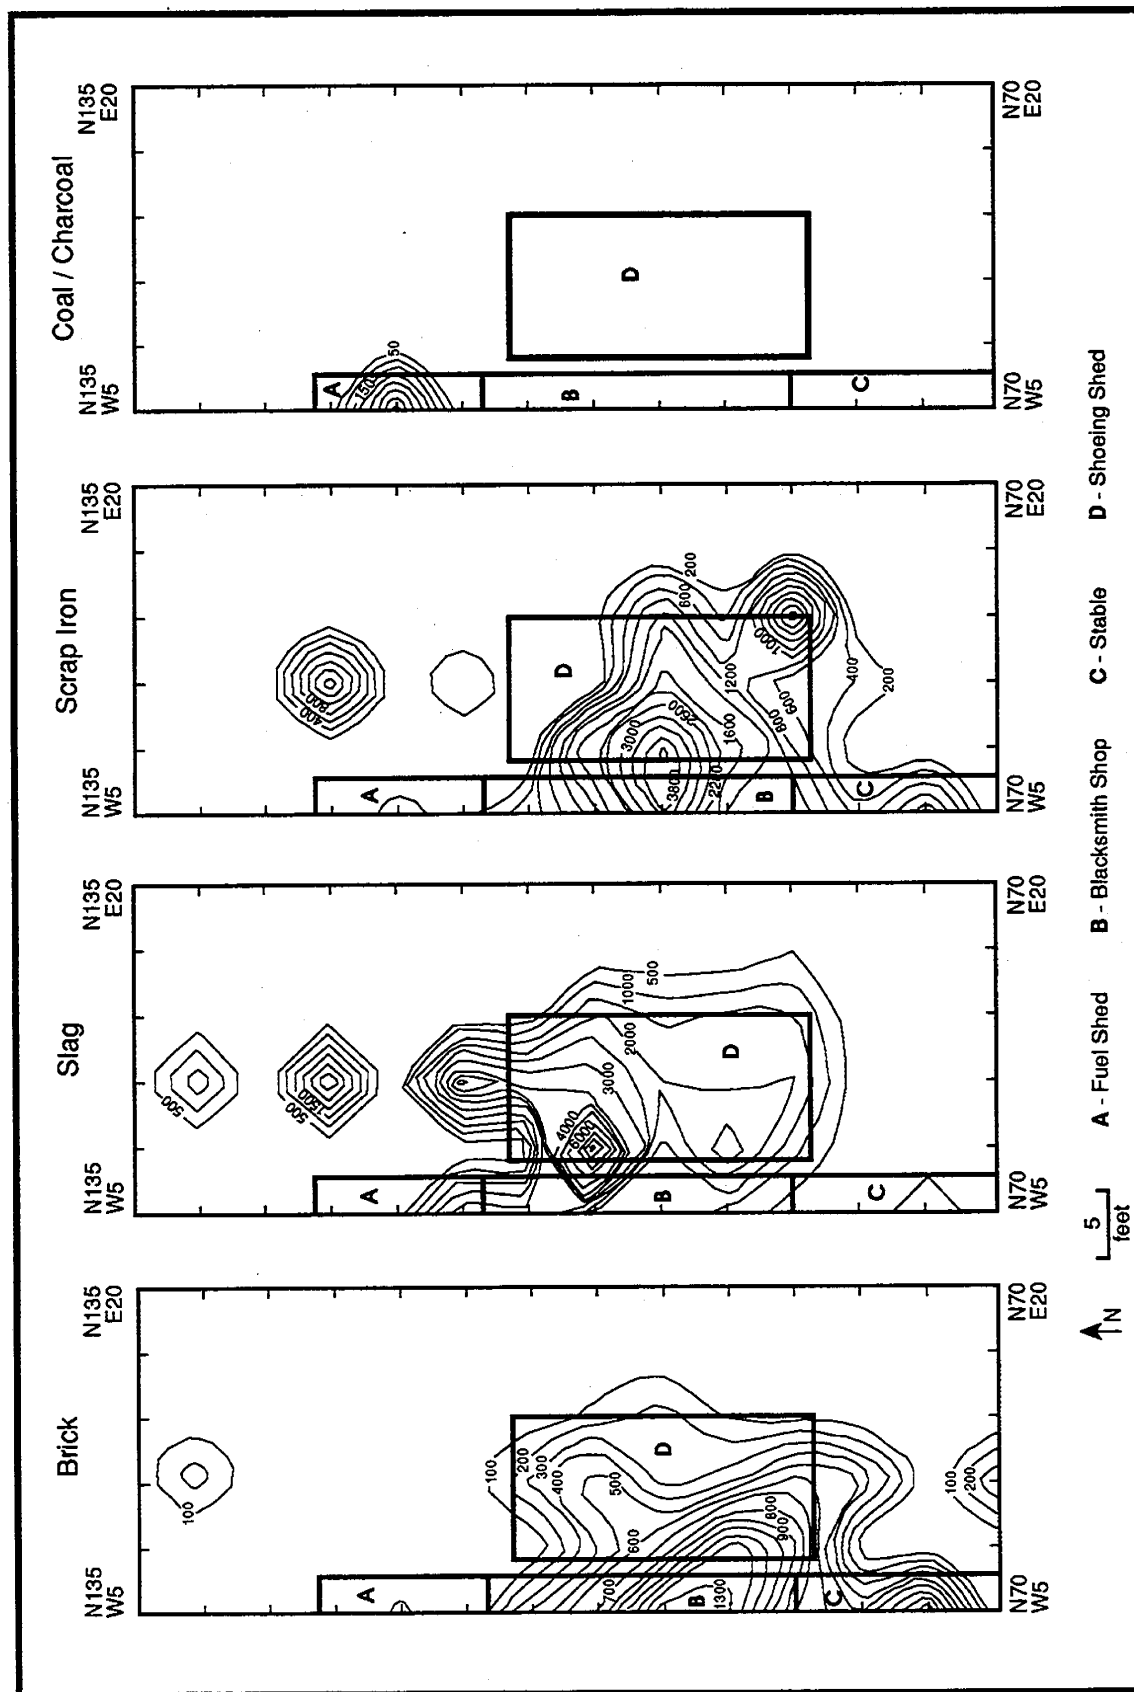
FIGURE 30
Distribution of Brick, Slag, Scrap Iron, and Coal / Charcoal Sherds in the
Plow Zone

Figure 30 illustrates the distribution of brick fragments by weight (in grams) across the site. The most dense concentration of brick was located inside the shop along the rear stone wall, perhaps indicating the approximate location of the hearth and forge. Certainly the large amount of burned brick and metal in Feature 18 supports this conclusion. A smaller peak of brick was located along the rear foundation wall at N75W5 (mentioned above), and a third peak was located in the area behind the stable. Finally, a large scattering of brick was found throughout the plow zone above the shoeing shed, perhaps indicating feature fill or the plow-smeared remnants of the hearth and forge.

Iron slag (Figure 30) was heavily concentrated within the limits of the shoeing shed, suggesting that the slag is associated with the features inside of the shed (Features 2 and 4). Additionally, slag was found concentrated in the plow zone above Feature 40 (the trash area behind the fuel shed), and in a

The distribution of scrap iron (Figure 30) was similar to the distribution of slag, but also exhibited some minor variations. The most dense concentration was again associated with the shoeing shed and particularly over Feature 4, but also with Feature 2 and the exterior shoeing pit east of the shed (Feature 8). Scrap iron was also concentrated in the plow zone above Feature 40.

Coal distributions were very different from the other blacksmith-related artifacts (Figure 30). Coal was recovered only from the area within the limits of the fuel shed, providing the archaeological evidence for interpreting that addition as a coal bunker.

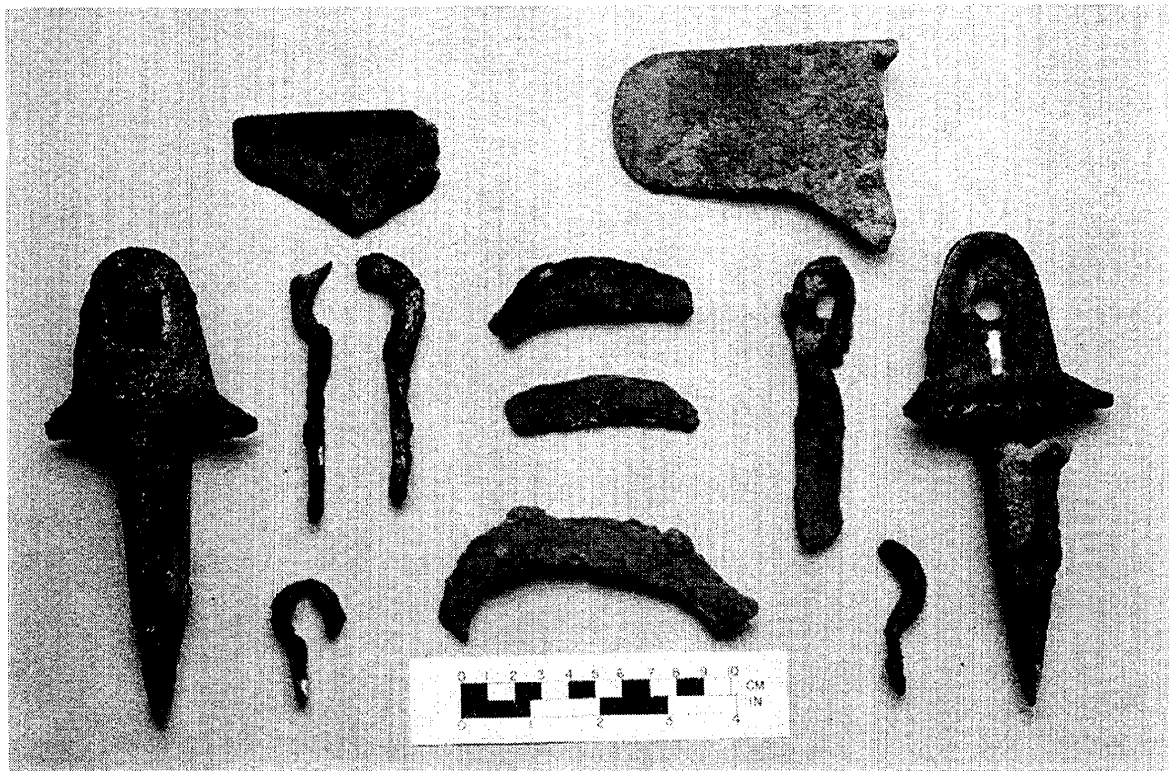
PLATE 34

Worn Hame Clips from Mermaid Blacksmith Shop and Stable Site

Based on the archaeological evidence, the horse trade and all that went with it undoubtedly took up most of the Mermaid blacksmiths' time. The robust horse shoes, many heavily worn and some completely worn through at the toe, were indicative of horses pulling heavy loads such as plows and wagons, or possibly wagon teams hauling limestone from the nearby quarries in the Pike Creek Valley (Cooch 1936:41-46). Worn hame clips, the metal loop at the end of harness reins that attach to the hame, and the metal yolk of horse collars, are indicative of draft work (Plate 34). The same can be said

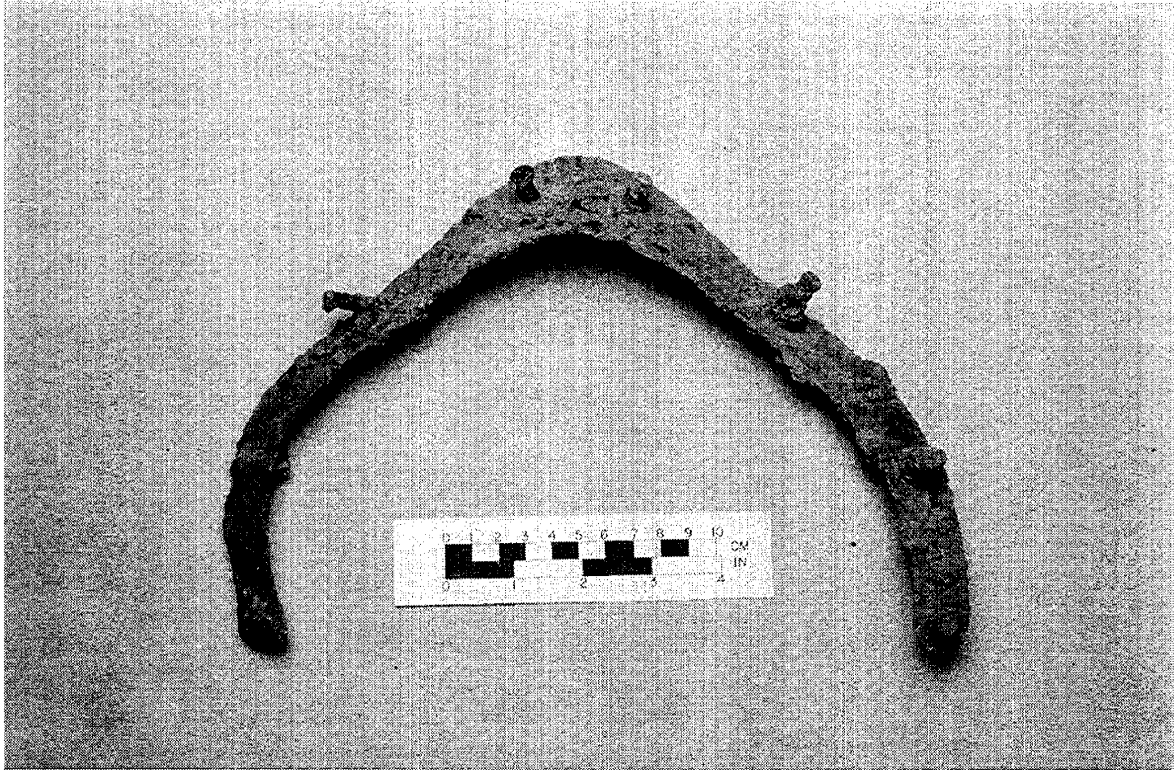
PLATE 35

Iron Support Bracket for English Saddle, Mermaid Blacksmith Shop and Stable Site

of the chain links which are ubiquitous on draft harnesses. A fragment of a large snaffle bit was also recovered; the size of this bit indicates a large horse. Other horse tack includes an iron support bracket for a saddle tree to an English saddle (Plate 35), a smaller snaffle bit for riding, a swivel hook, a small buckle that could belong to a bridle, and a possible hoof pick. The presence of cut off calkins, the metal cleats at the end of the horse shoe, indicate at least occasional use of machine-made horse shoes, artifacts that were being made at least as early as 1835 (Lasansky 1980:13) and were available by 1865 in a variety of catalogs (Nelson 1980:250).
